vol. 7 no. 2

a newsletter for ocean technologists

The Effects Of Fouling On Electromagnetic Current Meters

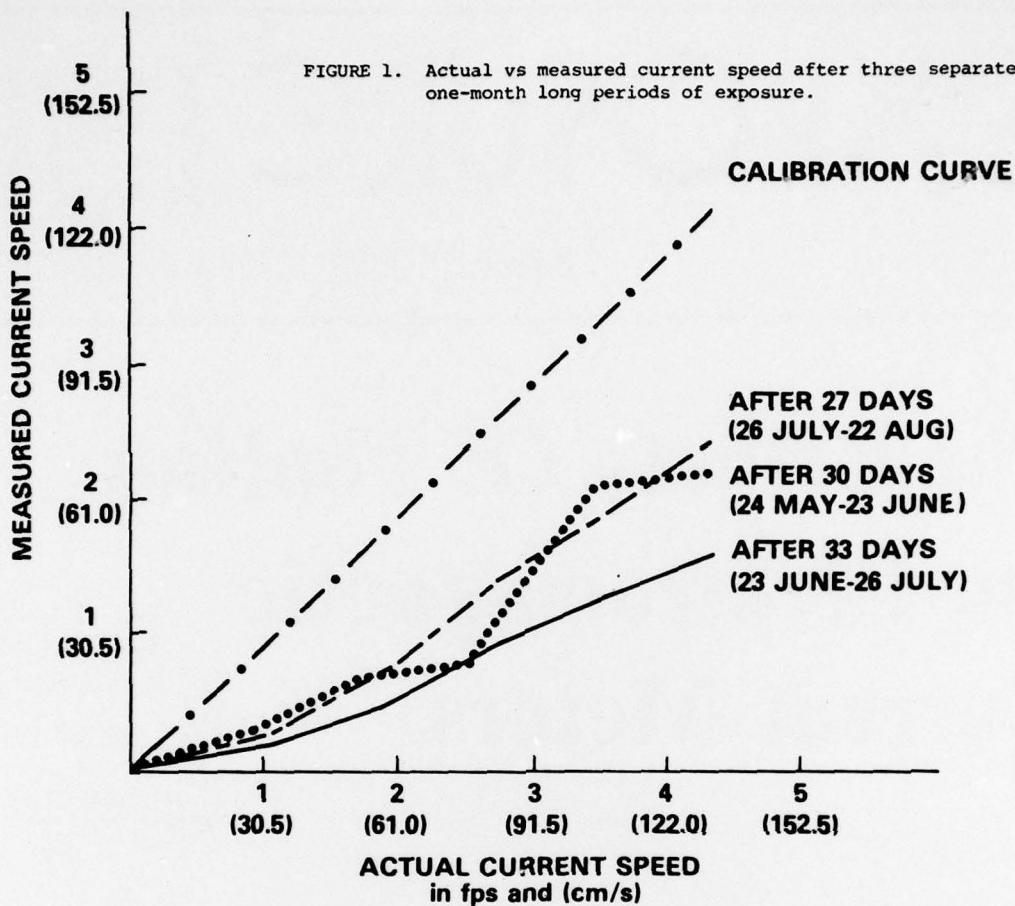
Figure 1 shows that large inaccuracies occurred after all three long periods of exposure. The differences in the three curves shown are probably due to the amount and type of organisms that were present during the period in question. Figure 2 clearly shows the increase in error of the meter as a function

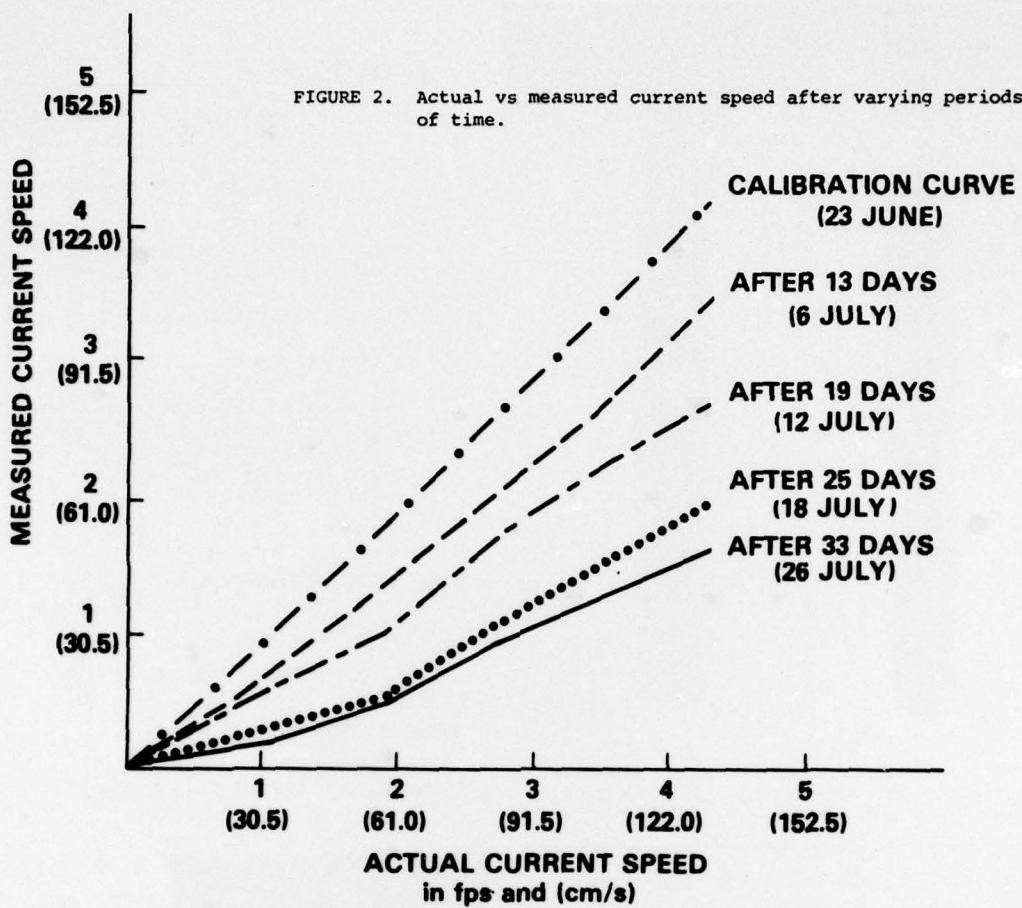
of the amount of time of exposure of the sensor to the fouling environment. It is significant to note that errors of as high as 31 percent below true current speed can be noted after only 13 days of exposure.

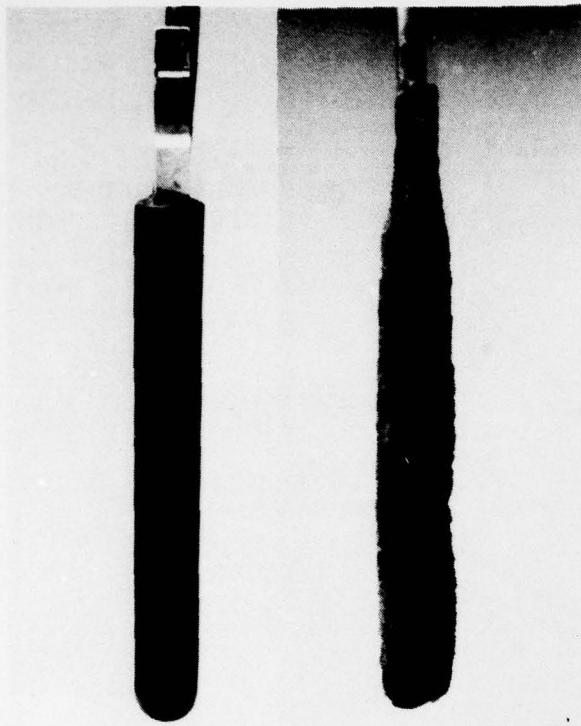
The types of fouling organisms present on the probe were quite variable depending on the particular season of immersion. Barnacles were the prime offenders for the period 24 May to 23 June, while brown algae were predominant for the remainder of the tests. Bryozoa were quite abundant during the last period, 26 May to 22 August. All tests were

run during the May-August period because, for the particular environment where the sensor was submerged, very little fouling occurs during the remainder of the year (Shaw, 1967). Figure 3 shows how the sensor looked unfouled and after it had been exposed to fouling organisms for 27 days (26 July to 22 August). No attempt was made to quantitatively determine the extent of fouling of the probe after any of the periods.

FIGURE 3. A comparison of the electromagnetic sensor before and after 27 days of exposure to fouling organisms.

As shown in Figures 1 and 2, unprotected sensors exposed for only a few days may exhibit errors of a magnitude sufficient to make measurements unacceptable for many purposes. Longer exposures can result in inaccuracies large enough to make data collected from fouled instruments completely useless. Any EMC M which will be deployed in a biologically active environment for more than a few hours must be equipped with an effective anti-fouling system which provides protection to the entire sensor as well as the electrodes themselves.
